FINAL REPORT

**Investigation on the accident
to PA-28-181
registration D-EREU
at Brno
on 14 November 2010**

Prague
January 2011

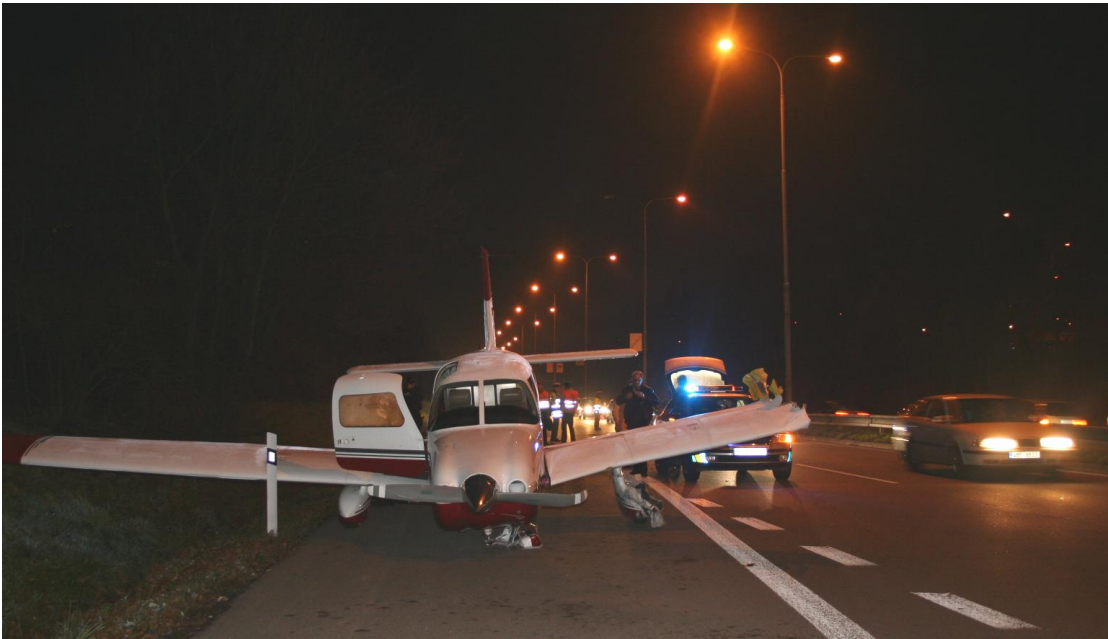
Fig. 3 Position of the emergency landing the aircraft PA-28-181 D-EREU

After the emergency landing the aircraft was at a distance of 13 km SE from ARP LKTB, its position being N 49° 14' 47.3'', E 16° 35' 20.9'', see Fig 3.

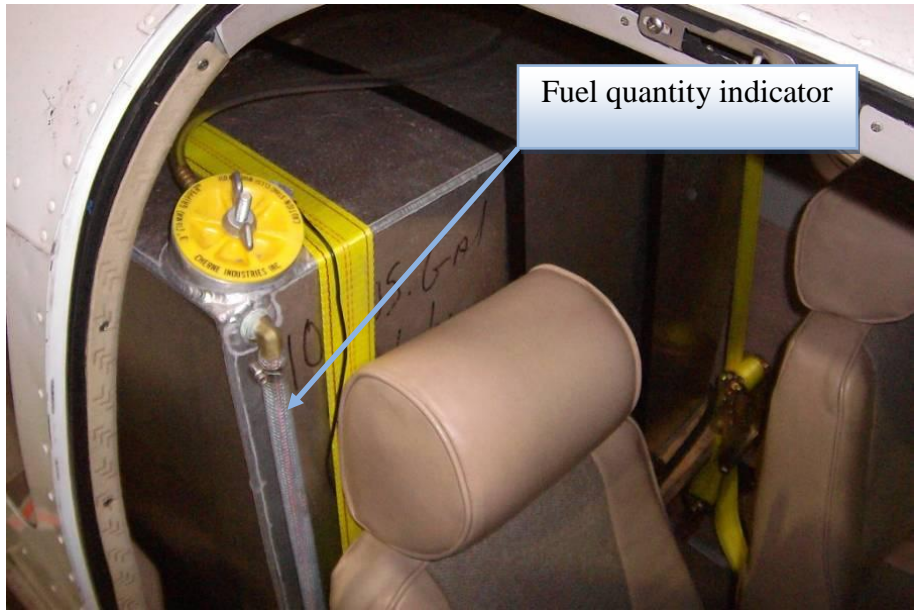
Fig 6. Auxiliary tank and fuel quantity indicator position

The auxiliary fuel cock controlled fuel supply from the extra tank and from the right wing tank. Since the vent system of the right wing tank remained in the original state, the auxiliary fuel cock also prevented the fuel from flowing out through this vent pipe. An amount of 100 l (26.4 U.S.gal) fuel was filled into the extra tank before take off.

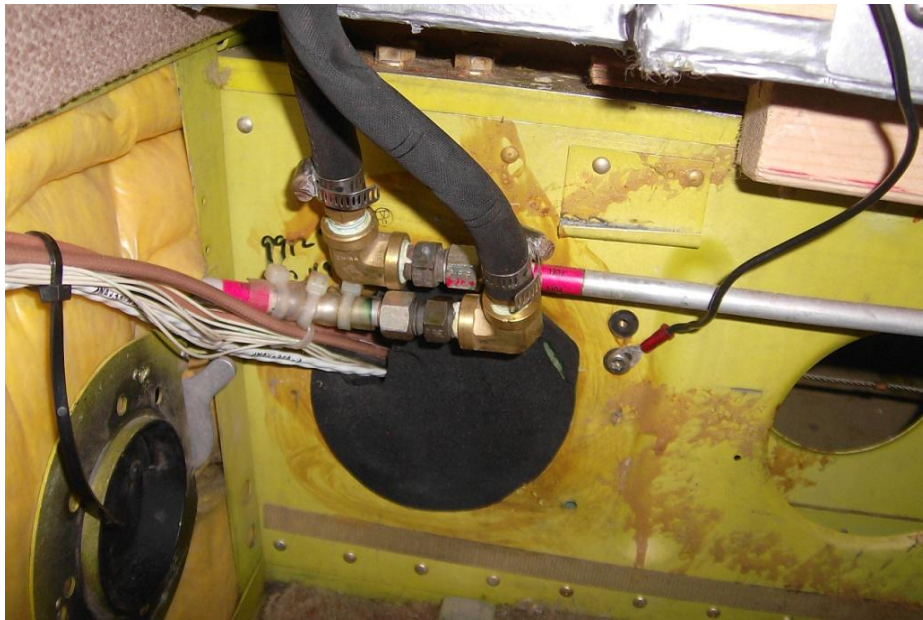
Fig 7. Auxiliary fuel system instalation place

Auxiliary fuel system was connected to pipe running from right wing tank to fuel tank selector valve.

Auxiliary fuel cock was placed down behind the seat back of the right front seat and was accessible to enable handling from pilot's post from the left front seat. The auxiliary fuel cock has three working positions.

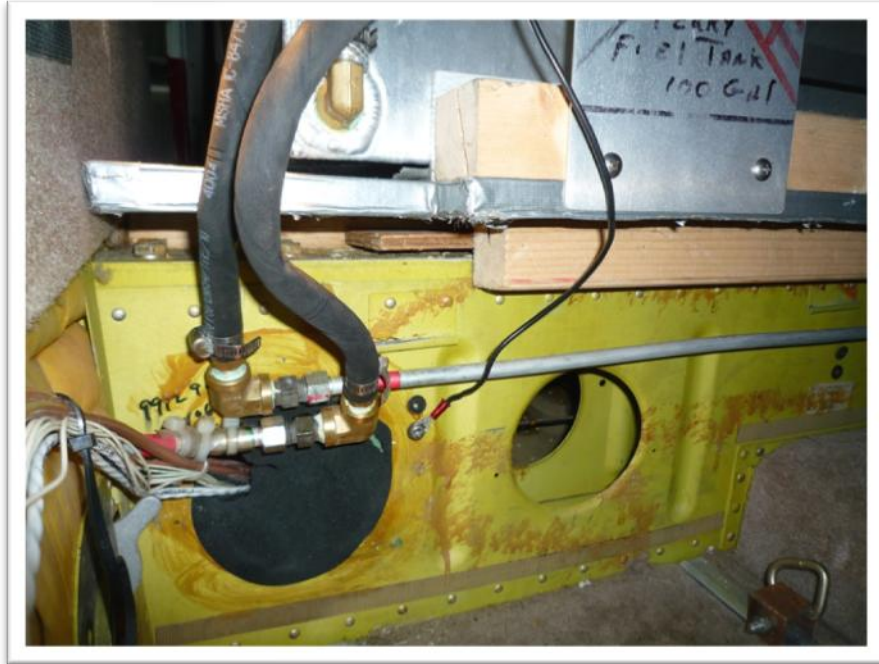
Fig. 9 Auxiliary fuel system instalation place

The pilot had failed to choose the right testing procedure when he tested the modified fuel system. Maybe he had not checked all the working positions of the fuel supply cock, omitting to test connection between the right wing fuel tank and pipe leading to the fuel supply cock. Therefore the pilot had not discovered the wrong connection of hoses before the flight.

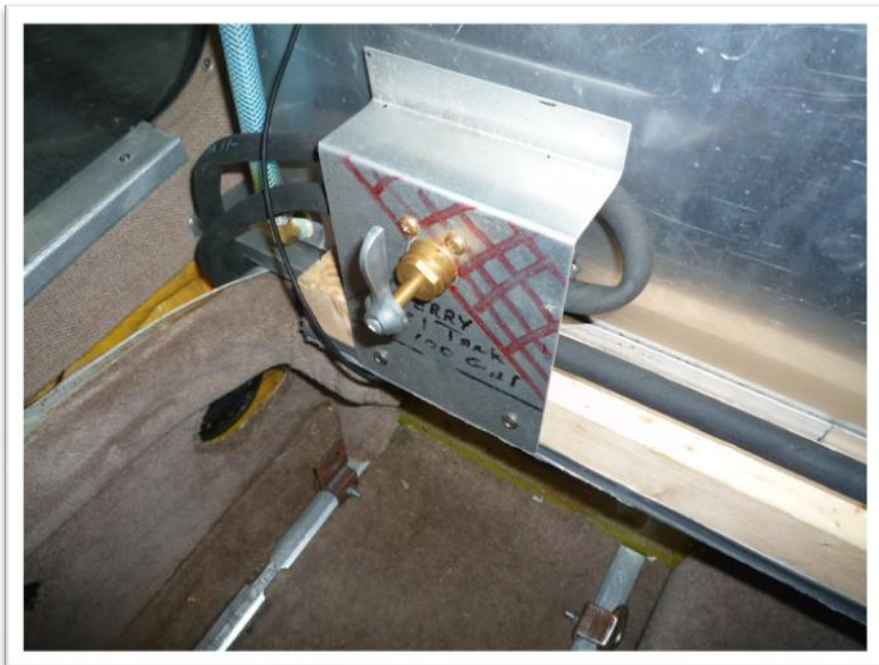
Fig. 10 Position of the lever auxiliary fuel cock after forced landing

Malfunction of the fuel system after the auxiliary fuel cock had been switched over to fuel supply from the right wing tank caused the fuel pressure and revolutions to drop, engine irregular run, and interruption of fuel supply to the engine. The pilot was not able to find out in flight what exactly the fuel problem was. The only information was the amount of fuel and its pressure as indicated on fuel meters and on auxiliary tank fuel gauge. The engine stopped working because there was no more fuel in the left wing tank and in the auxiliary tank, although there was enough fuel (approx. 90 l) in the right wing tank.
