Ref. No. CZ-09-046

FINAL REPORT

**Investigation of microlight aircraft accident, type UFM 13 Lambada
Registration Mark OK-NUA 09
on 21st March 2009**

Prague
December 2009

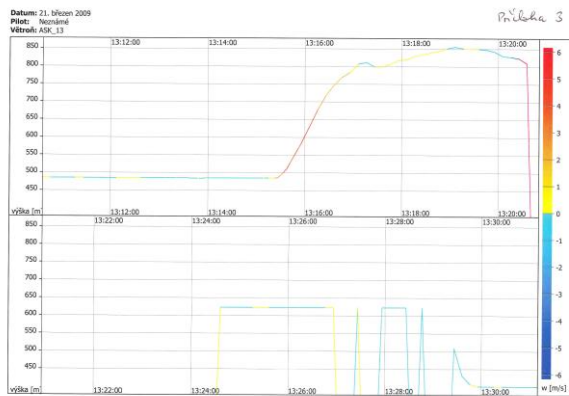
Altitude

On board the plane there was a “logger” recorder type FILSER LX 5000 IGC-220 GPS, s/n 01445. The instrument had been disconnected following the electricity cut off as the plane hit the ground. There was no visible damage to the instrument, which made it possible to evaluate the data recorded. The record was evaluated using a computer and a program provided by the operator.
