Ref. No. CZ 08/359

FINAL REPORT

**Investigation of Serious Incident A/C Airbus A 310, Registration OK-WAB,
on 31st July 2008 on KJFK**

Prague
June 2009

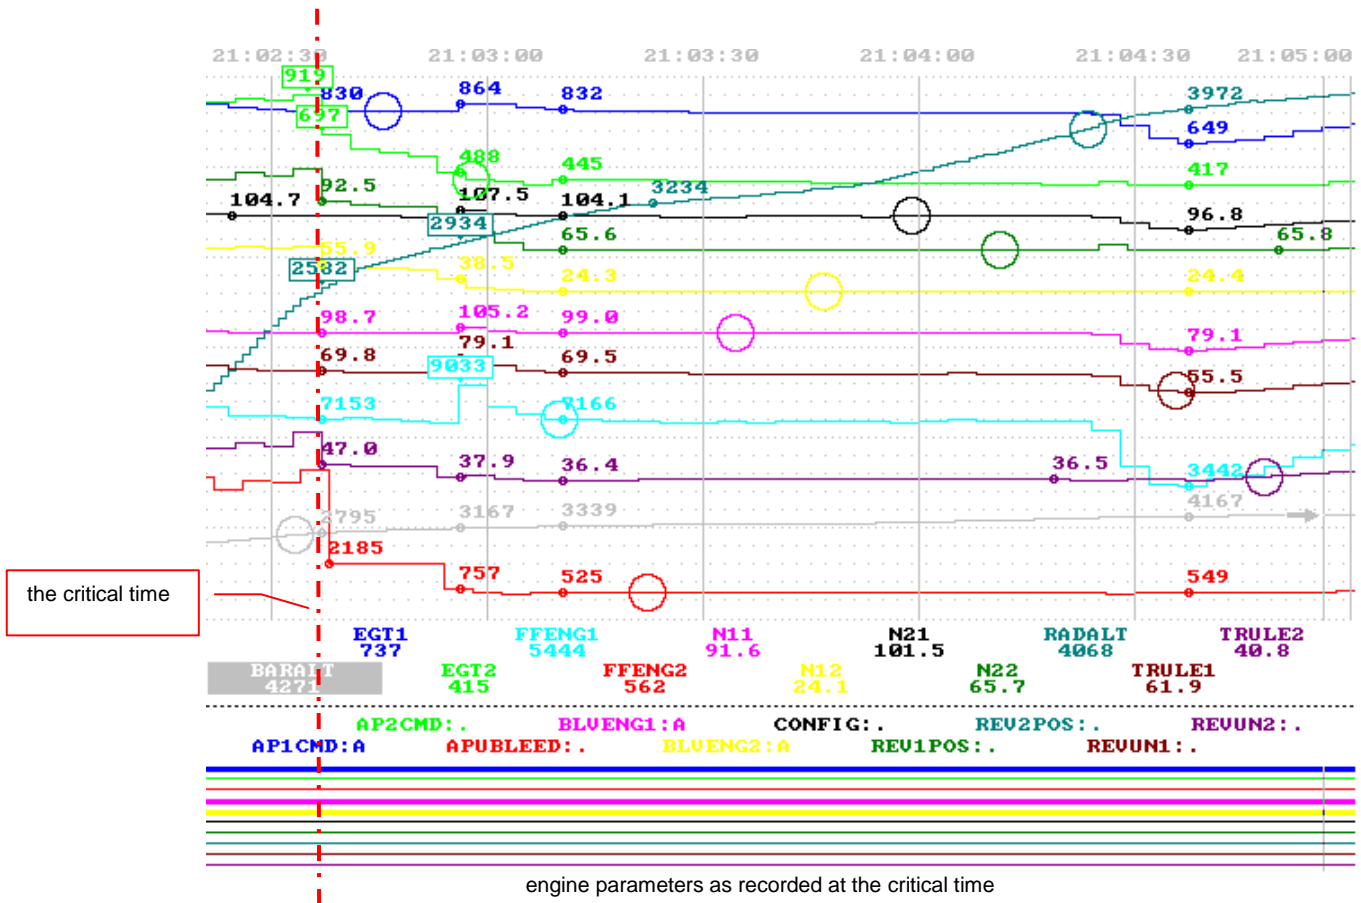
engine parameters as recorded at the Take off

- at BA 1,411 ft left turn began;
- at BA 1,255 ft first indications of engine no. 2 failure occurred (jump drop of N₁₂ from 102.1% to 83.2%);

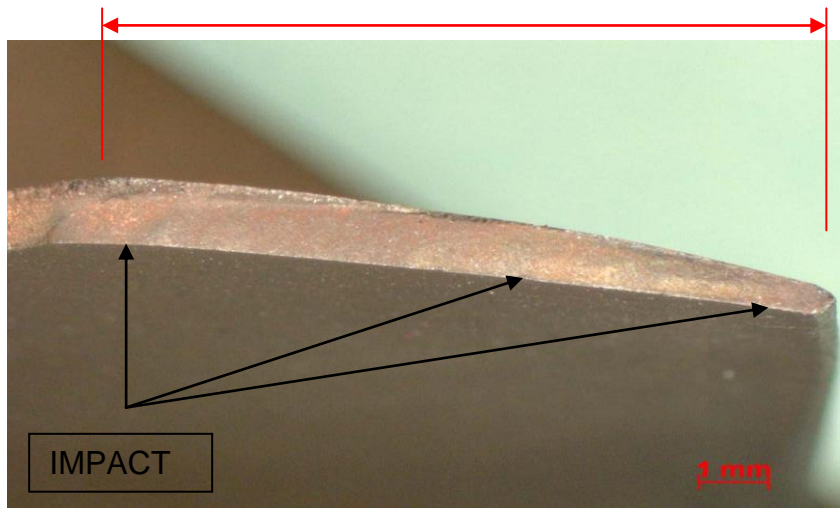
Fatigue area (40%)

HPC 11th stage blade: The blade is broken off at about 1/3 height from the end. The stub of the blade was sent to the lab for metallurgical examination of the fracture surface.

Macroscopic examination of the blade's fracture surface revealed a zone of fatigue fracture near the leading edge taking up around 40 percent of fracture surface.

Crack's front shape, as seen on the crack fracture surface after it has stopped, and typical marks of fracture surface indicate that the fracture originated just on the leading edge. The other blades of this stage show some traces of foreign object impact at leading edges at the same locations (further referred to as impact). A few small impacts are visible on the concave surface of the damaged blade along its full length. They are located at a place where the fracture surface runs through the blade profile. The mutual position of impacts after the crack stopped and the impact traces show that these small impacts took place only after the fatigue crack got initiated. Examination using an electron scanning microscope revealed that the fracture fatigue surface and the surface of the final break present different structures. EDX analysis did not reveal any organic matter on the profile surfaces.

The fracture nature corresponds to a high cycle fatigue mode.

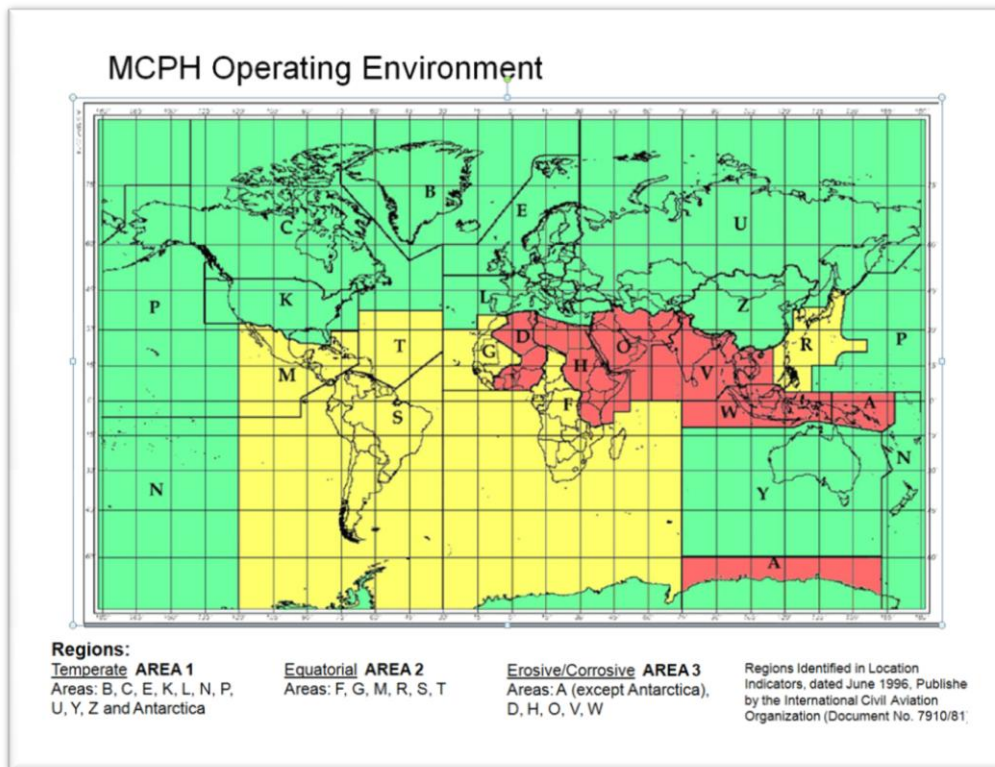
Long-term operation on routes across continents and oceans may cause hardened atmospheric pollutants to deposit on “mid span shrouds” (see ICAO Document 7910/81).
