CZ-14-587

FINAL REPORT

**Investigation Serious incident involving
of Airbus A319, registration mark OK-NEP,
in FIR Sofia and Istanbul on 9 September 2014.**

April 2015

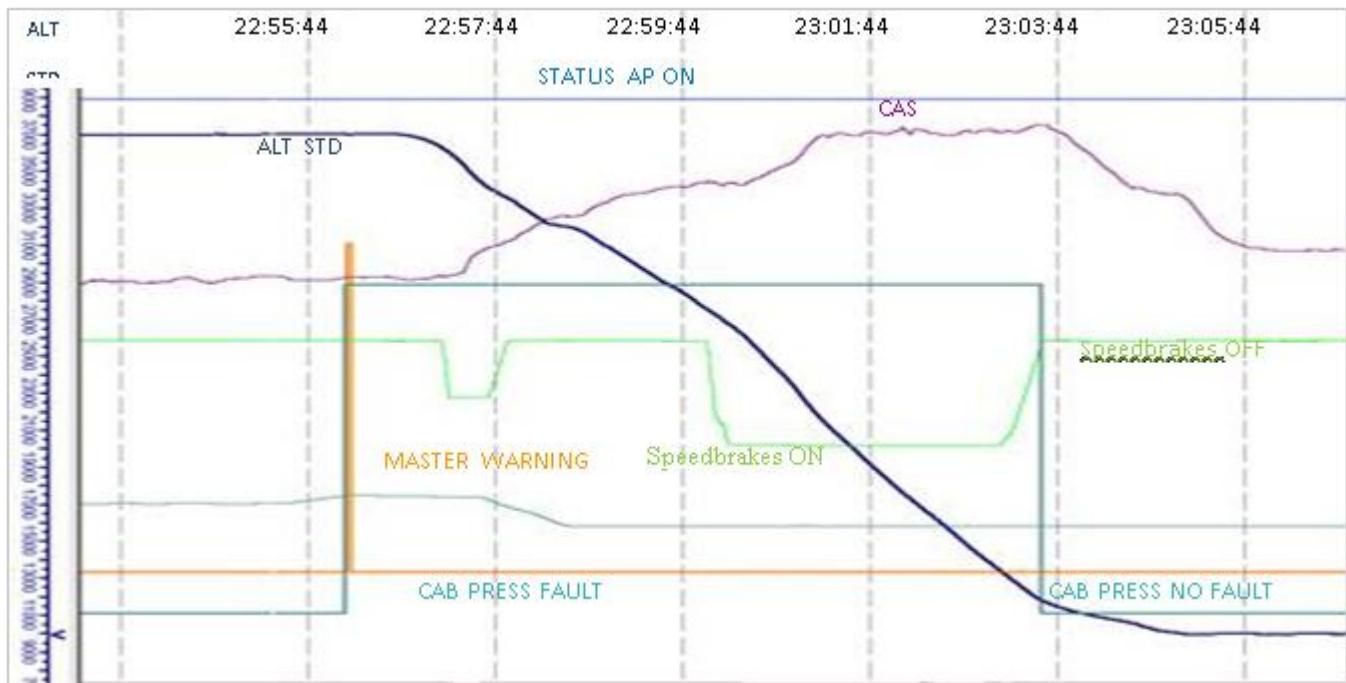
1.11.1 Selected parameters from WQAR data evaluation

22:56:09 FL370, speed Mach 0.78, autopilot AP1 engaged, 1FD2, A/THR ON, indication of Master Warning + CAB PRESS FAULT
22:56:35 Communication via VHF1, THR IDLE, descent initiation with FL 100 set
22:57:51 Speed brakes retracted at FL 335, heading set to 096°, THR IDLE
22:58:21 FL 321, SELECT FL 240, THR IDLE, V/S – 3,120 ft/min
22:58:46 FL 314 communication via VHF1, SELECT FL 100
22:59:59 FL 275 Speed brakes were extended, V/S max – 6,360 ft/min at FL 228
23:03:34 FL117 Speed brakes retracted, Cabin Press – NO FALT
23:05:07 FL 100 reached
23:39:28 FL 100 left and the flight to LBBG continued
23:53:00 Landing at LBBG completed
