**FINAL REPORT ON THE ACCIDENT  
TO THE HOT AIR BALLOON KUBICEK  
SPOL. S.R.O. – BB37N  
REGISTERED OO-BHA IN OUDENBURG ON  
22 APRIL 2011**

Ref. AAIU-2011-09  
Issue date: 30 September 2011  
Status: draft FINAL v2

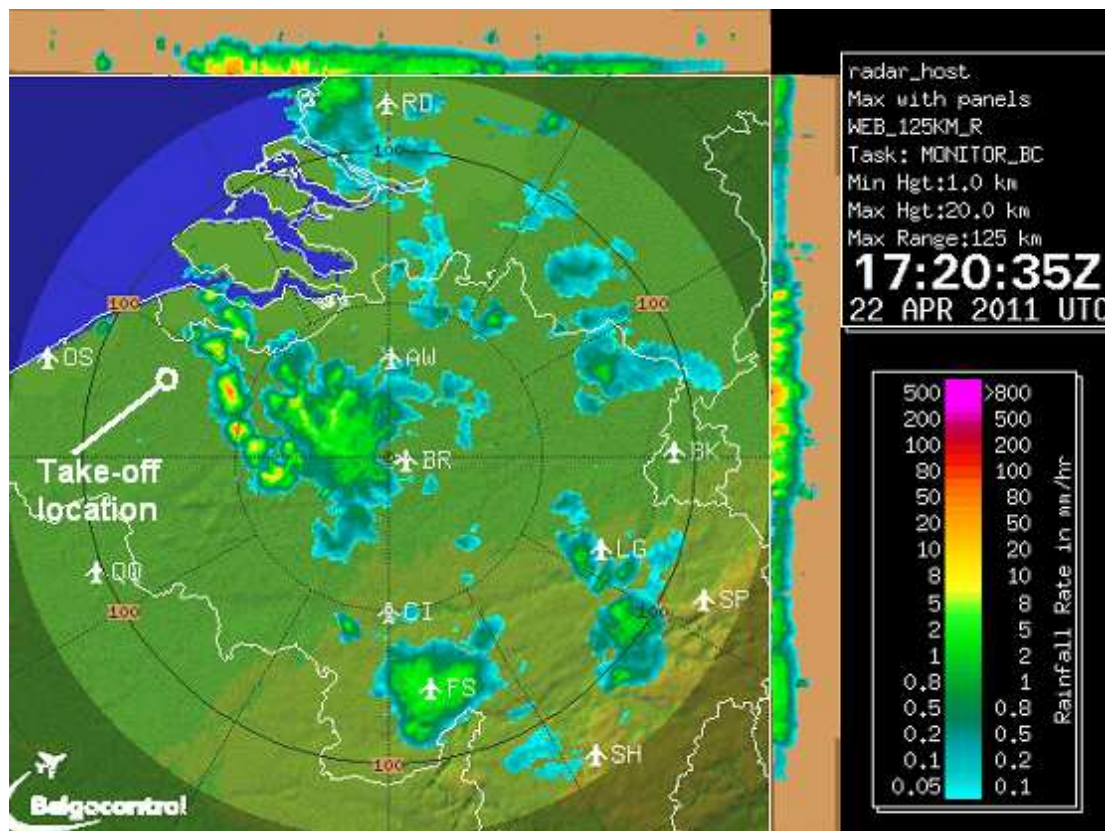
At take-off

The weather condition before take-off was favourable, as also the weather radar image :

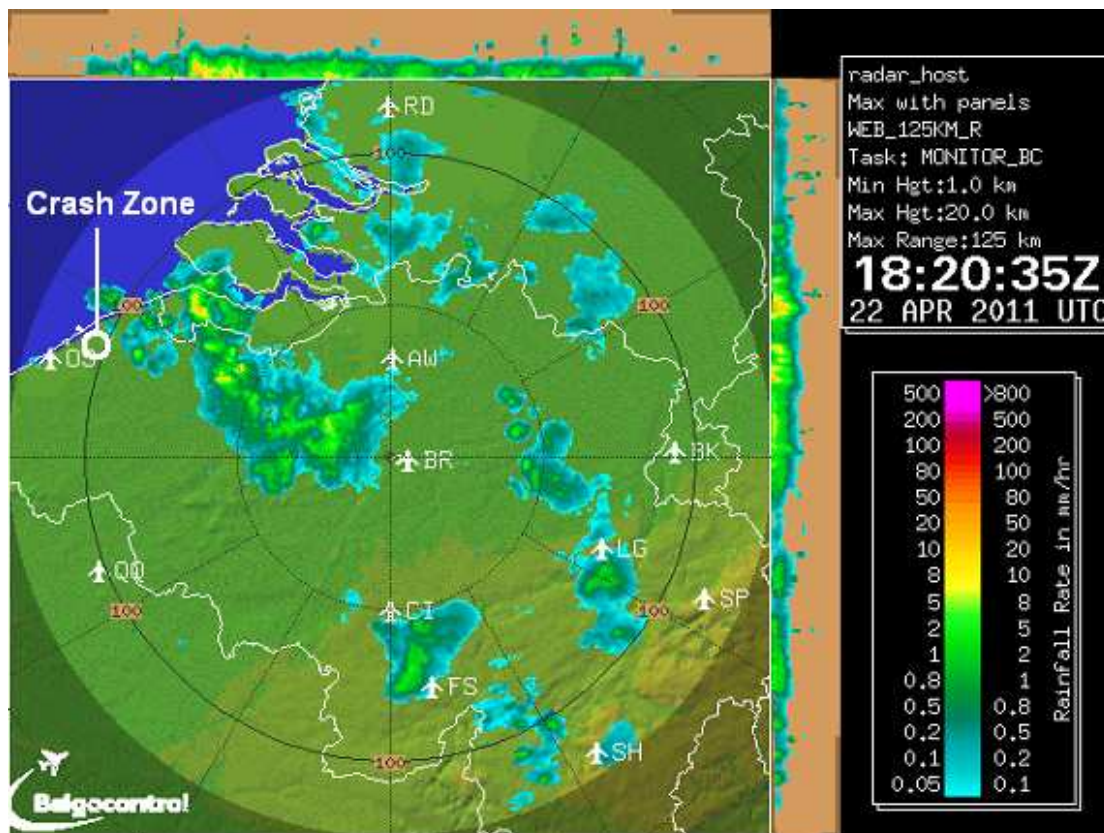
Upon landing

A wind gust close to the ground increased the ground speed to 43 km/h, increasing the impact forces upon touch down. As the basket could not be positioned perfectly with respect to the ground, the touchdown caused the basket to swivel round one of the corner.

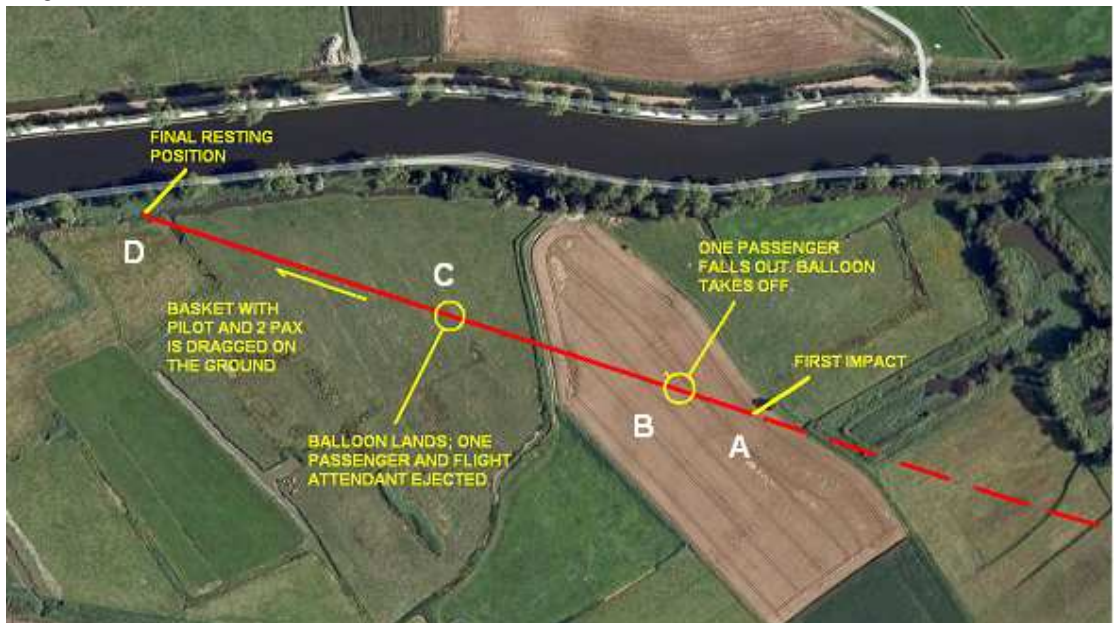
The balloon reached the tree line, and the basket went into the ditch, before stopping.

The ground crew member dashed to the rescue of the passengers, and finally came to the final resting place of the balloon. The pilot was still trapped under water, inside the basket, still held by the safety belt. The ground crew member released the pilot with the help of a passer-by, and brought him to firm ground. They applied Cardio-Pulmonary Resuscitation (CPR), without success.
